January 9, 2012

RE: Completion Report  
AHERA 6-Month Periodic Surveillances

## AHERA Six Month Periodic Surveillance Listings of Damaged Asbestos-Containing Materials

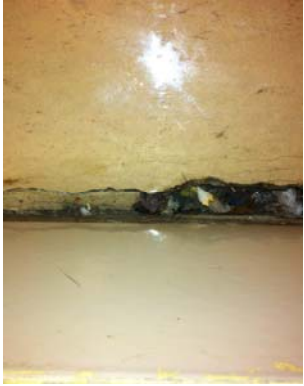
#9

Location	Material(s)	Recommended Action	Round Added
Room 9 <i>(photo # 9)</i>	9"x9" Floor Tile	Remove/Repair damaged tiles along walls	DEC. 2012
Room 10 <i>(photo # 9)</i>	9"x9" Floor Tile	Remove/Repair damaged tiles along walls	DEC. 2012
Custodial Office <i>(photo #10&amp;11)</i>	9"x9" Floor Tile	Remove/Repair damaged tiles	DEC. 2012
Room A-2 <i>(photo # 12)</i>	Pipe Insulation	Repair small holes/exposed material	DEC. 2012
Room B-3 Pipe Chase <i>(photo # 13)</i>	Pipe Insulation	Repair one exposed elbow	DEC. 2012

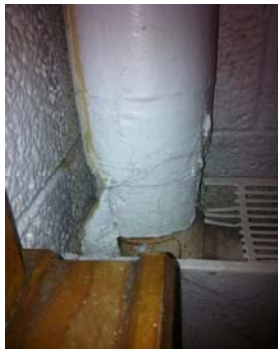
#1

Location	Material(s)	Recommended Action	Round Added
Room 8- S/E corner at heat unit <i>(photo # 1)</i>	Straight Pipe Insulation	Repair loose wrap	DEC. 2012
Room 20- S/W corner at heat unit <i>(photo # 2)</i>	Straight Pipe Insulation	Repair loose wrap	DEC. 2012
Kindergarten 1- above Bathroom door & Bathrooms <i>(photo # 3&amp;4)</i>	Straight Pipe Insulation	Repair damaged/exposed material	DEC. 2012
Kindergarten 2- Bathrooms <i>(photo #5&amp;6)</i>	Straight Pipe Insulation	Repair/Remove damaged material	DEC. 2012
Hallways & Classrooms above LICT <i>(photo # 7)</i>	Trowelled On Ceiling Material	Repair exposed material from ceiling grid hangers	DEC. 2012

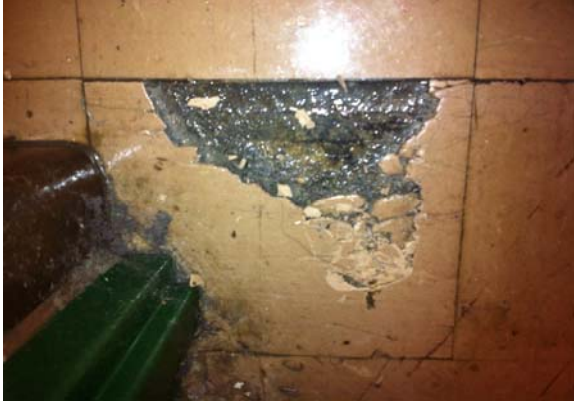
#14

Location	Material(s)	Recommended Action	Round Added
Throughout <i>(photo # 14&amp; 15)</i>	9"x9" Floor Tile	Remove/Repair	DEC. 2012
Gym Storage <i>(photo # 16&amp;17)</i>	Pipe Insulation	Repair exposed/hanging material	DEC. 2012
Tunnel (access in stairwell b/w Assistant Princ. Office & Men's Faculty Bathroom) <i>(photo # 18)</i>	Pipe Insulation	Remove loose/cut pipe & debris	DEC. 2012

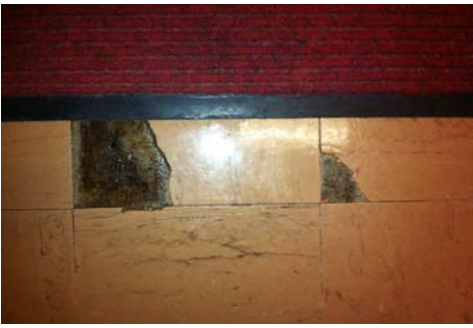
#19

Location	Material(s)	Recommended Action	Round Added
Main Entrance <i>(photo # 19-22)</i>	9"x9" Floor Tile	Remove/Repair damaged tiles	DEC. 2012
Room 4 Bathroom <i>(photo # 23)</i>	Smooth Plaster Ceiling Material	Remove/Repair	DEC. 2012
Room 10 <i>(photo # 19-22)</i>	9"x9" Floor Tile	Repair whole missing tiles	DEC. 2012
Room 15 <i>(photo # 19-22)</i>	9"x9" Floor Tile	Remove damaged tiles along walls	DEC. 2012
Room 17 <i>(photo # 19-22)</i>	9"x9" Floor Tile	Repair whole missing tiles	DEC. 2012
Room 21 <i>(photo # 19-22)</i>	9"x9" Floor Tile	Remove damaged tiles	DEC. 2012
Room 23 <i>(photo # 19-22)</i>	9"x9" Floor Tile	Remove damaged tiles	DEC. 2012
Room 24 <i>(photo # 19-22)</i>	9"x9" Floor Tile	Repair damage/exposed material	DEC. 2012
Receiving Room <i>(photo # 24)</i>	Pipe Insulation	Repair damage/exposed material	DEC. 2012
Hallways & Classrooms above LICT <i>(photo # 25)</i>	Trowelled On Ceiling Material	Repair exposed material around ceiling grid hangers	DEC. 2012

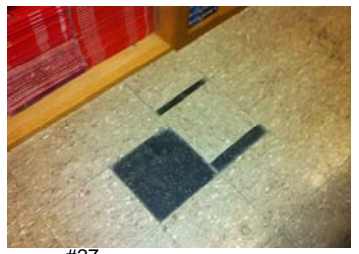
#27

Location	Material(s)	Recommended Action	Round Added
Hallway outside of Room 115 (photo # 33)	9"x9" Floor Tile	Repair	DEC. 2012
Room 114 Science Lab (photo # 32)	9"x9" Floor Tile	Repair	DEC. 2012
Receiving Room at Exit Door (photo # 34)	9"x9" Floor Tile	Remove damaged tiles	DEC. 2012
Stage (photo # 27)	9"x9" Floor Tile	Remove damaged tiles	DEC. 2012
Cafeteria at Stage & Exit (photo # 26)	9"x9" Floor Tile	Remove whole loose tiles	DEC. 2012
North Hall near Serving & Boys Locker Room (photo # 35)	Pipe Insulation	Repair one damaged elbow	DEC. 2012
Hall outside of Room 211 (photo # 28)	9"x9" Floor Tile	Remove damaged floor tile	DEC. 2012
Hallway outside of Room 210/211 (photo # 36)	Roof Drain Insulation	Remove/Repair damaged material & debris	DEC. 2012
Room 214 (photo # 31)	9"x9" Floor Tile	Remove damaged floor tile	DEC. 2012
Room 200D next to Staff Lounge (photo # 29)	9"x9" Floor Tile	Remove damaged tile	DEC. 2012

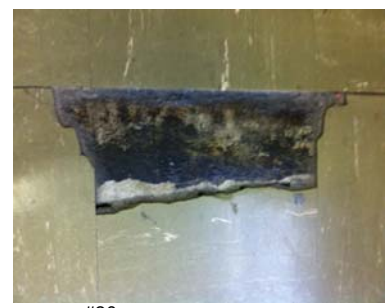
#30

Hall outside of Room 205 (photo # 30)	9"x9" Floor Tile	Remove damaged tile	DEC. 2012

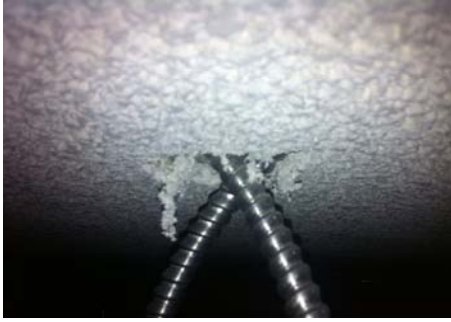
Location	Material(s)	Recommended Action	Round Added
Hallways & Classrooms above LICT (photo #46 & 47 )	Trowelled On Ceiling Material	Repair exposed material around electrical systems and ceiling grid hangers	DEC. 2012
Art Room 101 Storage (photo # 48 )	Straight Pipe Insulation	Repair exposed ends	DEC. 2012
Custodial Closet next to Room 101 (photo # 49)	Straight Pipe Insulation	Repair one exposed end	DEC. 2012

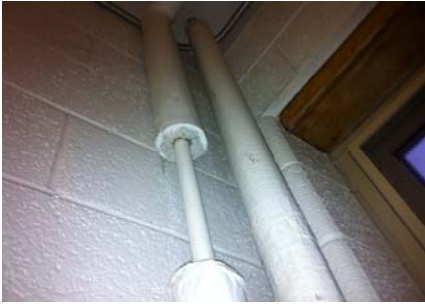
#37

Location	Material(s)	Recommended Action	Round Added
Main Hall Boys & Girls Bathrooms (photos #37&38)	Pipe Insulation	Repair exposed ends	DEC. 2012
Room 12 (photo # 41-45)	9"x9" Floor Tile Mastic	Repair whole missing tiles	DEC. 2012
Room 25 (photo # 41-45) (photo # 38)	9"x9" Floor Tile & Mastic	Remove/Repair damaged tiles & exposed mastic	DEC. 2012
Rooms 26 (photo # 41-45) (photo # 40)	Pipe Insulation	Repair exposed ends	DEC. 2012
Room 32 (photo # 41-45)	9"x9" Floor Tile & Mastic	Remove/Repair damaged tiles & exposed mastic	DEC. 2012
Room 35 (photo # 41-45)	9"x9" Floor Tile & Mastic	Remove/Repair damaged tiles & exposed mastic	DEC. 2012
