January 9, 2012

RE: Completion Report  
AHERA 6-Month Periodic Surveillances

## AHERA Six Month Periodic Surveillance Listings of Damaged Asbestos-Containing Materials

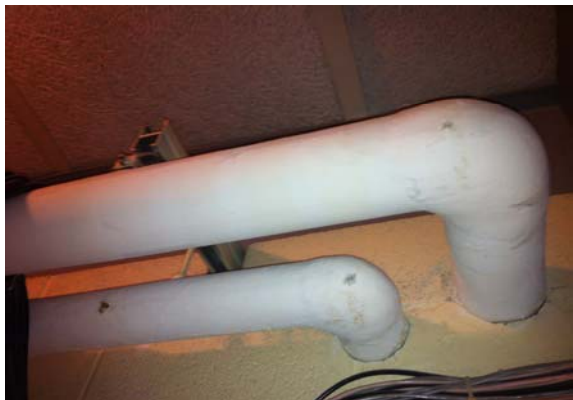
#12

Location	Material(s)	Recommended Action	Round Added
Room 9 <i>(photo # 9)</i>	9"x9" Floor Tile	Remove/Repair damaged tiles along walls	DEC. 2012
Room 10 <i>(photo # 9)</i>	9"x9" Floor Tile	Remove/Repair damaged tiles along walls	DEC. 2012
Custodial Office <i>(photo #10&amp;11)</i>	9"x9" Floor Tile	Remove/Repair damaged tiles	DEC. 2012
Room A-2 <i>(photo # 12)</i>	Pipe Insulation	Repair small holes/exposed material	DEC. 2012
Room B-3 Pipe Chase <i>(photo # 13)</i>	Pipe Insulation	Repair one exposed elbow	DEC. 2012

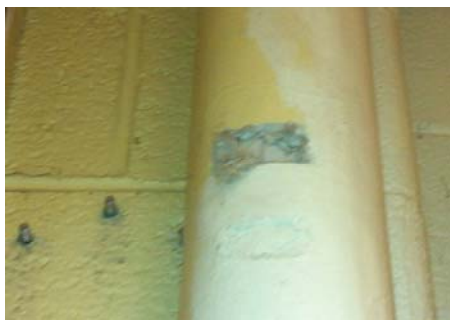
#3

Location	Material(s)	Recommended Action	Round Added
Room 8- S/E corner at heat unit <i>(photo # 1)</i>	Straight Pipe Insulation	Repair loose wrap	DEC. 2012
Room 20- S/W corner at heat unit <i>(photo # 2)</i>	Straight Pipe Insulation	Repair loose wrap	DEC. 2012
Kindergarten 1- above Bathroom door & Bathrooms <i>(photo # 3&amp;4)</i>	Straight Pipe Insulation	Repair damaged/exposed material	DEC. 2012
Kindergarten 2- Bathrooms <i>(photo #5&amp;6)</i>	Straight Pipe Insulation	Repair/Remove damaged material	DEC. 2012
Hallways & Classrooms above LICT <i>(photo # 7)</i>	Trowelled On Ceiling Material	Repair exposed material from ceiling grid hangers	DEC. 2012

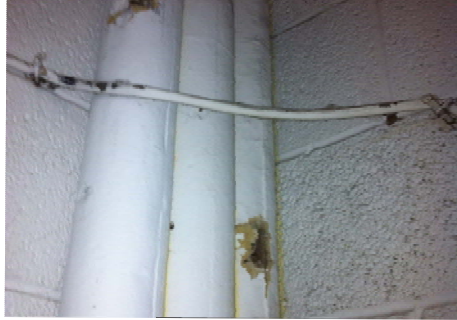
#24

Location	Material(s)	Recommended Action	Round Added
Main Entrance <i>(photo # 19-22)</i>	9"x9" Floor Tile	Remove/Repair damaged tiles	DEC. 2012
Room 4 Bathroom <i>(photo # 23)</i>	Smooth Plaster Ceiling Material	Remove/Repair	DEC. 2012
Room 10 <i>(photo # 19-22)</i>	9"x9" Floor Tile	Repair whole missing tiles	DEC. 2012
Room 15 <i>(photo # 19-22)</i>	9"x9" Floor Tile	Remove damaged tiles along walls	DEC. 2012
Room 17 <i>(photo # 19-22)</i>	9"x9" Floor Tile	Repair whole missing tiles	DEC. 2012
Room 21 <i>(photo # 19-22)</i>	9"x9" Floor Tile	Remove damaged tiles	DEC. 2012
Room 23 <i>(photo # 19-22)</i>	9"x9" Floor Tile	Remove damaged tiles	DEC. 2012
Room 24 <i>(photo # 19-22)</i>	9"x9" Floor Tile	Repair damage/exposed material	DEC. 2012
Receiving Room <i>(photo # 24)</i>	Pipe Insulation	Repair damage/exposed material	DEC. 2012
Hallways & Classrooms above LICT <i>(photo # 25)</i>	Trowelled On Ceiling Material	Repair exposed material around ceiling grid hangers	DEC. 2012

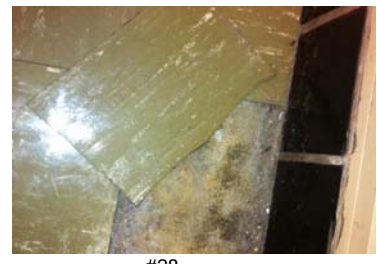
#28

Location	Material(s)	Recommended Action	Round Added
Hallway outside of Room 115 (photo # 33)	9"x9" Floor Tile	Repair	DEC. 2012
Room 114 Science Lab (photo # 32)	9"x9" Floor Tile	Repair	DEC. 2012
Receiving Room at Exit Door (photo # 34)	9"x9" Floor Tile	Remove damaged tiles	DEC. 2012
Stage (photo # 27)	9"x9" Floor Tile	Remove damaged tiles	DEC. 2012
Cafeteria at Stage & Exit (photo # 26)	9"x9" Floor Tile	Remove whole loose tiles	DEC. 2012
North Hall near Serving & Boys Locker Room (photo # 35)	Pipe Insulation	Repair one damaged elbow	DEC. 2012
Hall outside of Room 211 (photo # 28)	9"x9" Floor Tile	Remove damaged floor tile	DEC. 2012
Hallway outside of Room 210/211 (photo # 36)	Roof Drain Insulation	Remove/Repair damaged material & debris	DEC. 2012
Room 214 (photo # 31)	9"x9" Floor Tile	Remove damaged floor tile	DEC. 2012
Room 200D next to Staff Lounge (photo # 29)	9"x9" Floor Tile	Remove damaged tile	DEC. 2012
